# THE TAWHIAO COTTAGE

REPORT TO  
THE NEW ZEALAND HISTORIC PLACES TRUST  
AND  
AUCKLAND COUNCIL

HPA AUTHORITY 2011/115

MATTHEW CAMPBELL, JADEN HARRIS,  
WESLEY MAGUIRE AND STUART HAWKINS

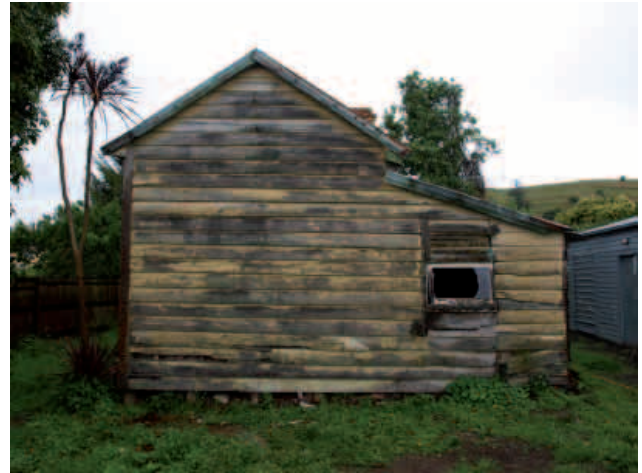
14 (top). Western elevation of the building showing the gable roof and skillion roof of the lean-to.

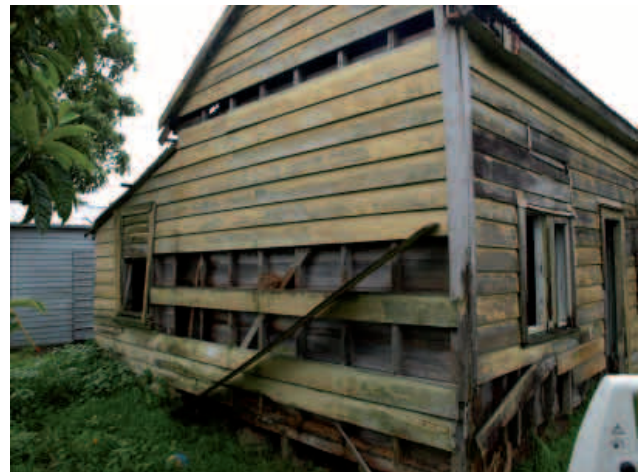
15 (centre). Detail of the north east corner of the building showing where weatherboards had fallen away from the structure.

fallen away to leave the building frame exposed in places (Figure 15). In addition to this the roof was no longer weather tight.

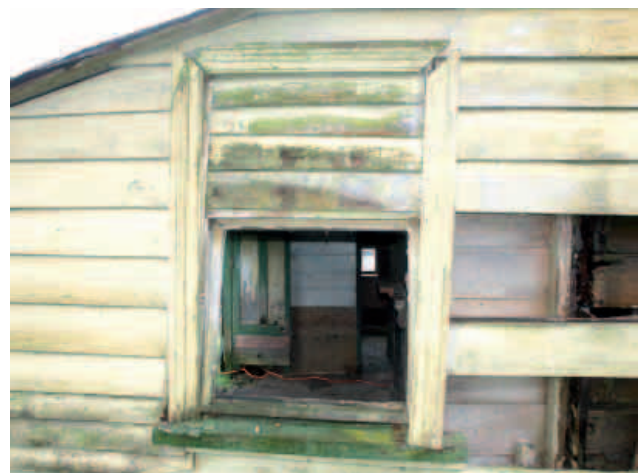
16 (bottom). Detail of the east elevation showing the location of an original window and the inserted window.

All of the original windows of the building have been replaced with smaller horizontal rectangular windows at some point in the 20th century and this altered the appearance of the building. The structural parts of the building frame, which would have supported the original windows, remained in situ and the spaces surrounding the inserted windows had been infilled with mismatched weatherboards.

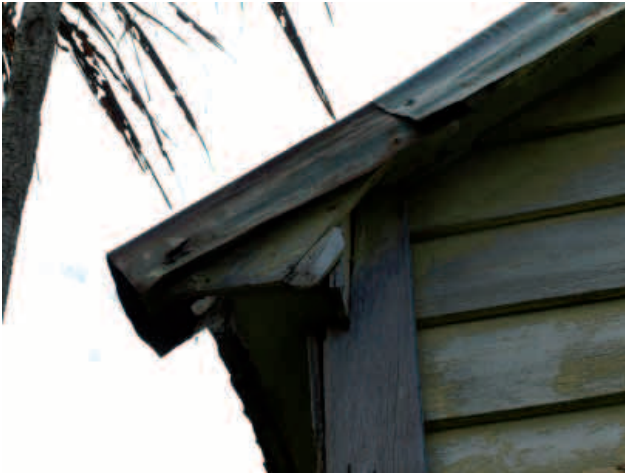
17 (top). Detail of the west elevation showing a fragment of timber at the north west corner of the roof suggested that there also had been decorative fretwork present.

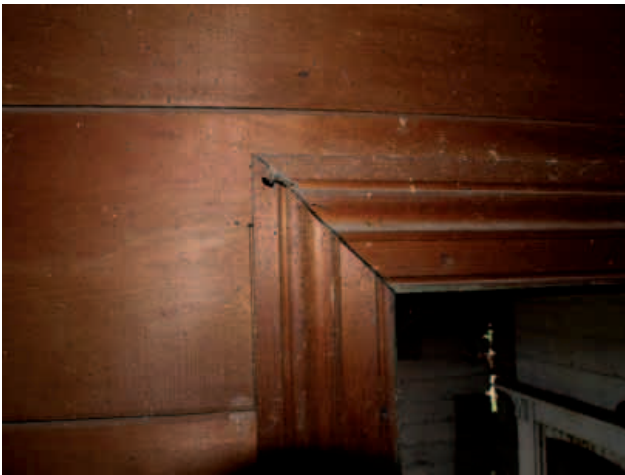
18 (centre). Detail of the wall linings in G2 showing the use of tongue and groove boards with bevelled edges.

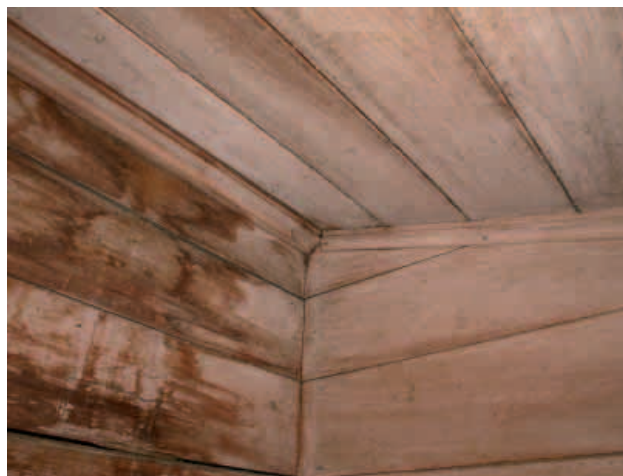
20 (top). Detail of the ceiling in room G3 showing the use of simple timber mouldings to edge the ceiling.

The ceilings of the lean-to rooms, G3 and G4, followed the line of the skillion roof and were clad with planed tongue and groove boards with a bevelled edge detail identical to the boards used to line the walls of the building. The ceilings of these rooms had been painted in the same manner as their walls. A simple timber moulding was used to edge the ceilings (Figure 20). The ceiling in G3 had been damaged by water which had led to the floorboards decaying in this room.

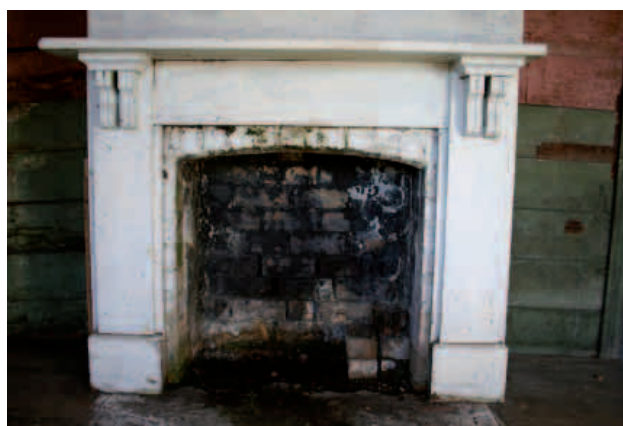
21 (centre). The fireplace surround in room G1.

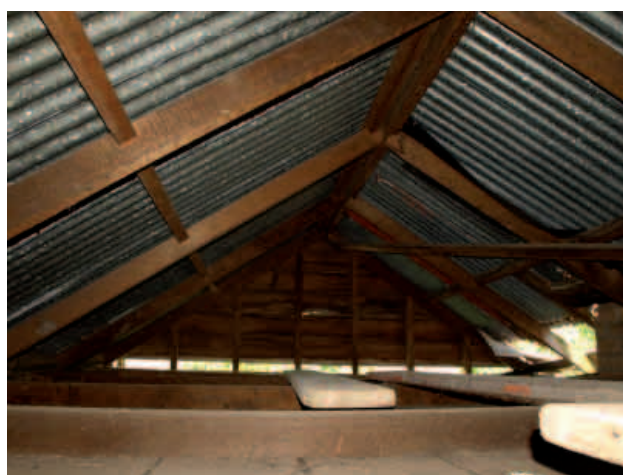
22 (bottom). The interior of the gable roof showing the ridge board, rafters, purlins, cross brace (on southern side of roof) and ceiling joists.

The only modification to the roof structure was a series of extra purlins which were present along the lower part of the south side of the roof. This vernacular repair to the roof was made up

of recycled pieces of timber nailed between the rafters. All other timbers observed in the roof were original to the building and had been cut by machine using a circular saw blade.

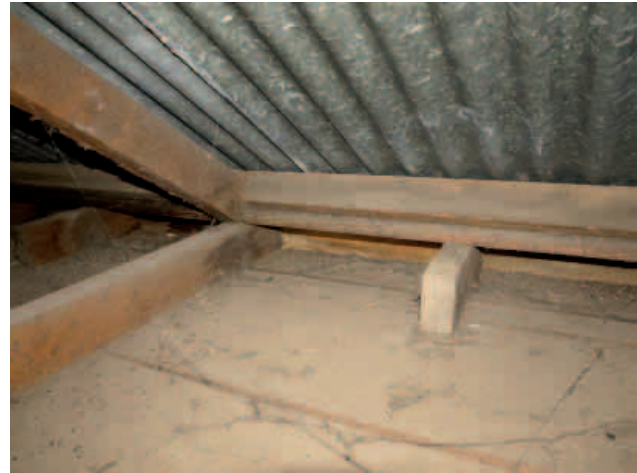
24 (top). Detail of the roof structure showing that the rafters were resting directly on the ceiling joists, which were resting on the top plate of the wall.

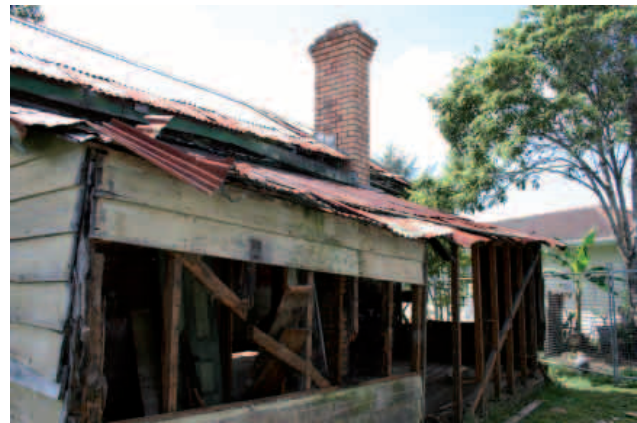
25 (centre). Detail of the south wall of the lean-to, during deconstruction, showing diagonal nogs between the wall studs.

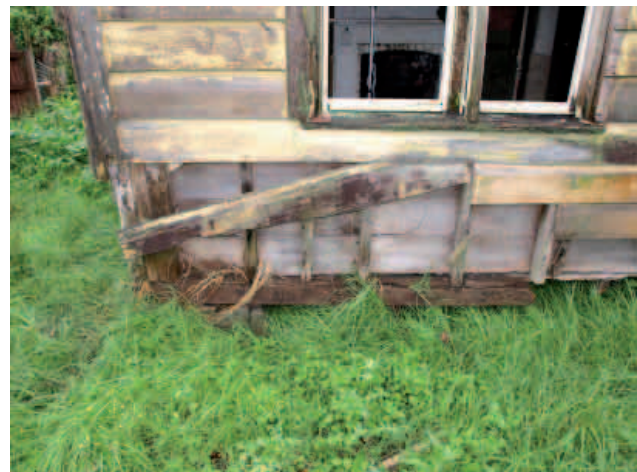
26 (bottom). Detail of the north wall showing the floorboards cut around the wall studs.

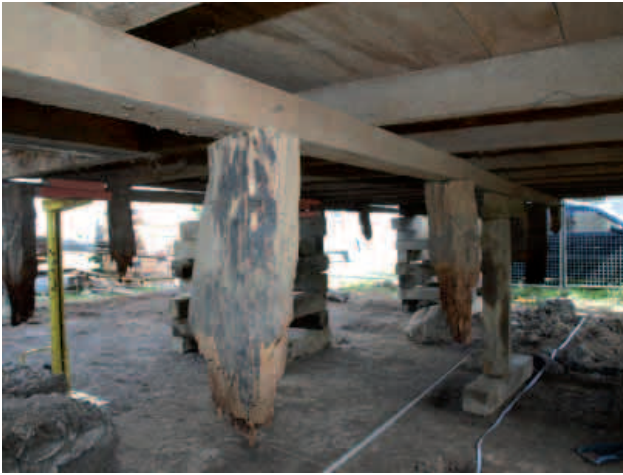
27 top). Detail of the main bearer after lifting of the building, showing the lap joint joining the two pieces of timber with puriri piles still attached.

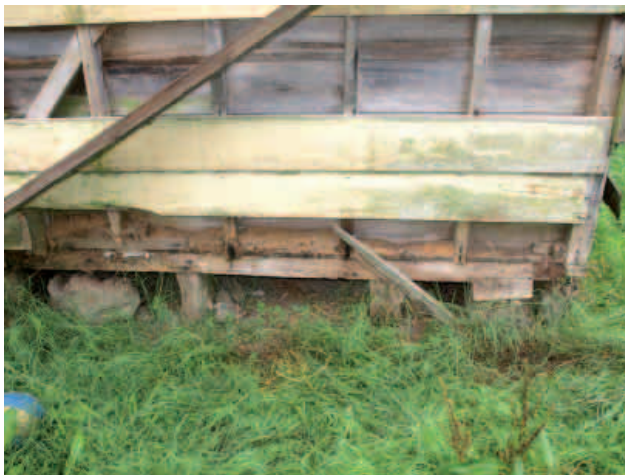
28 (bottom). Detail of the east end of the building, showing the use of puriri piles and basalt rocks to support the building.

The use of both puriri and basalt rocks used to support the building is a result of the later addition of the basalt rocks as replacements for wooden piles that had deteriorated. The basalt had been inserted under the building where the original wooden piles had decayed or become unstable.

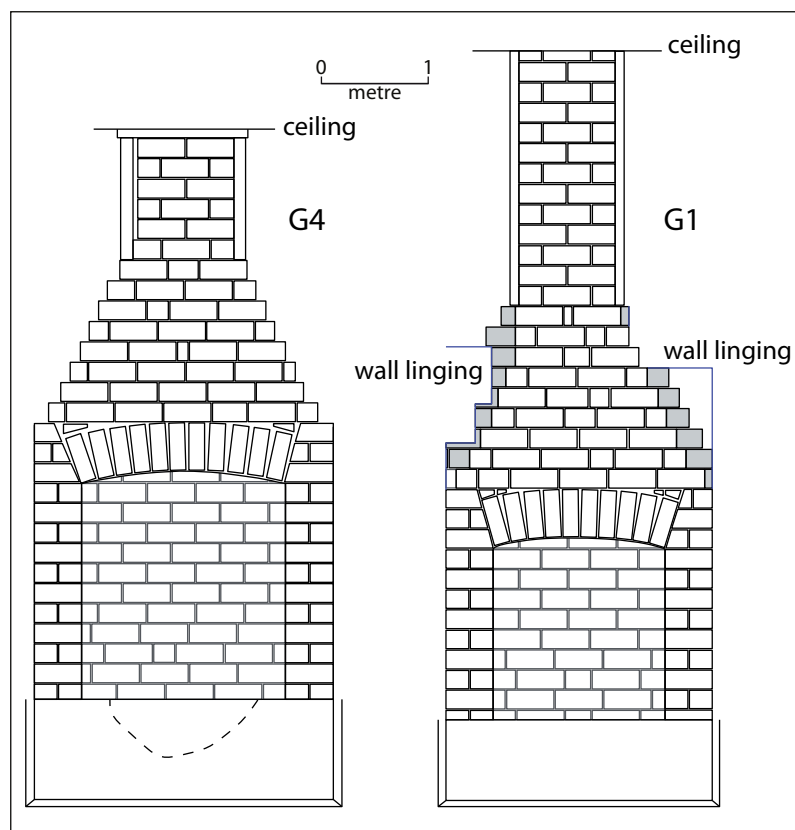
29 (above). The chimney and fireplace within room G4, following deconstruction of the lean-to.

The building contained a back-to-back fireplace located between G1 and G4 which shared a single chimney. The chimney base and hearths had been constructed as one feature as opposed to a hearth supported within the subfloor structure. The material used to construct the base and heath consisted of basalt and shell loosely bonded together with a concrete skim forming a surface of the hearth and the fireplace.

The chimney and fireplaces had been built on top of this base from brick mortared with concrete. The bricks were yellow in colour with a rectangular frog. At present the brick maker is unknown. The fireplaces were constructed with a rounded arch with an iron brace above the openings. During deconstruction of the fireplaces it was evident the fireplace in G4 was of a larger size and in order to accommodate this the brick work extended further out than that in G1. The chimney flue stepped in from the fireplace becoming narrower and extending through the roof of the building (Figure 29). The chimney top was not overtly ornate in style and consisted of a simple stepped design. No chimney pots were present and it is unclear if a chimney pot was ever present.

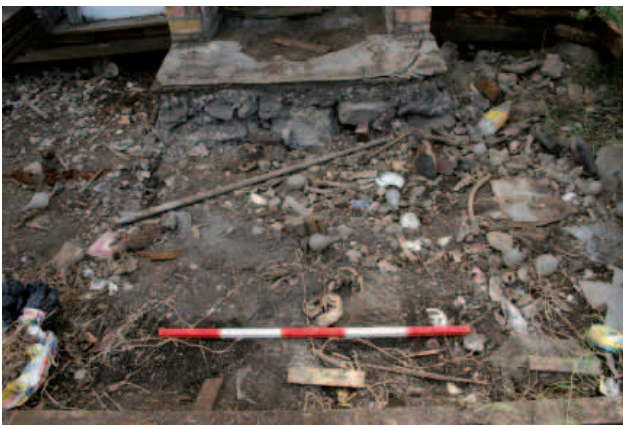
32 (top). Rubbish, old and new, exposed under G4 once the floor had been lifted. Scale = 1 m.

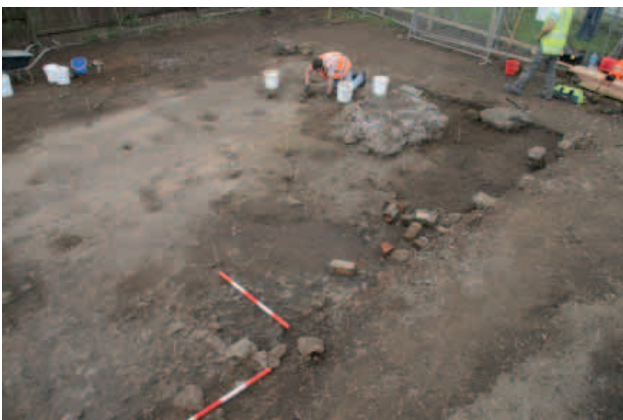
33 (bottom). The cottage footprint excavation in progress, showing the exposed fireplace and chimney foundation, bricks and rubble under the floor in the area around the back door, and scoria rubble under the floor of G3. Scales = 1 m.

The largest feature in the footprint of the cottage was the fireplace and chimney foundation. The north part of the foundation was partly damaged and destroyed during removal of the cottage and so only the southern half was investigated in detail. A large amount of oyster shell and other midden material was present around the fireplace foundation and as the investigation proceeded it became evident that some of this material at least had been used in the construction of the chimney foundation. This measured 1500 mm wide x 450 mm high and had originally been 2200 mm long, and was constructed of irregular scoria rocks partly set into the natural subsoil, with smaller stones and rubble in between and then shell midden used as levelling fill and the top plastered over with a concrete skim. Midden from the centre of the fireplace was capped by the plaster layer and a bulk sample was taken for analysis. The fireplace in the cottage had been a back-to-back construction with brick open fireplaces in G1 and G4 sharing a brick chimney.

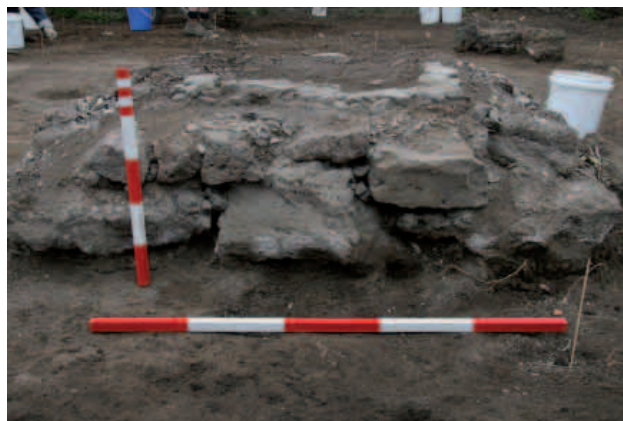
34 (top). Fireplace and chimney base showing the plastered hearth surface with layer of levelling midden below on a foundation of irregular scoria rocks. Scales = 1 m and 0.5 m.

As the fireplace foundation was deconstructed evidence of rat disturbance continued right down to the base, with some burrows even undermining the bottom layer of stones. The larger stones were not mortared together but were simply set into a shallow footing with smaller stones, soil and midden used as packing in between. On the north side of the foundation, which had been disturbed when the cottage was moved, two postholes were present that had been dug, then filled back in and the foundation built over the top. The fireplace appears to be original as there is no evidence of later rebuilding or substantial repair.

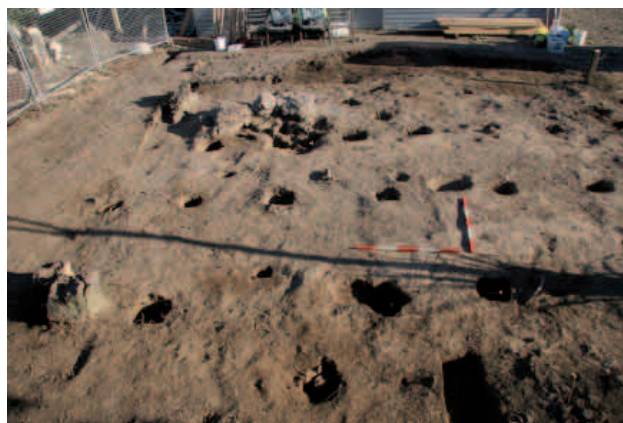
35 (bottom). The cottage footprint after excavation. Scales = 1 m.

initially left in place and worked around, but at the end of the excavation as they were removed many were found to be resting on mixed soil and artefacts, indicating that they had been added later. The postholes for the main puriri house piles were arranged in five regular rows running east-west (Figure 31).

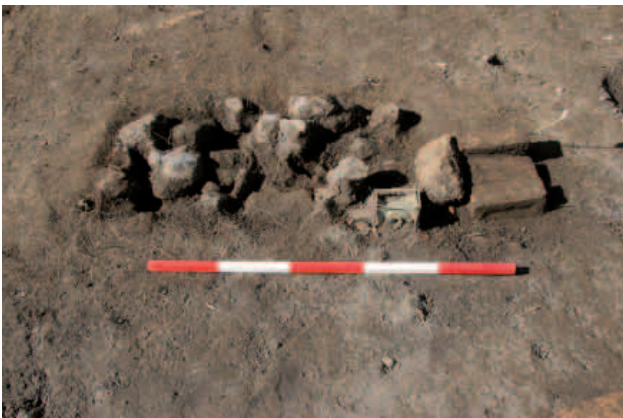
36. Feature 63 before excavation with pile of bricks and kerosene lamp on the south side. Scale = 1 m.

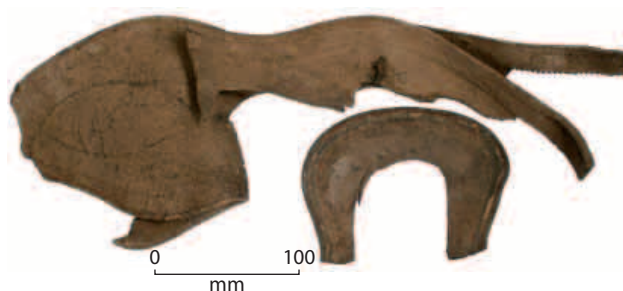
54 (top). Leather horse tack pieces.

Distinctive among the metal and leather artefacts from the underfloor deposit are several items of horse gear. The most instantly recognisable objects are iron horseshoes, with four whole and one fragmentary example recovered. The largest horseshoe has maximum dimensions of 170 x 170 mm and the smallest 150 x 145 mm. A complete spur with maximum dimensions of 140 mm long x 100 mm wide was also found. Other metal items which are likely to be related to horse gear are three large brass buckles. One is a square single-framed buckle 60 x 60 mm and one a rectangular double-framed buckle 63 x 42 mm, both with iron tangs. Another slightly smaller brass single-framed buckle with an iron tang 52 x 48 mm may also be from horse tack. Two pieces of leather definitely appear to be from horse tack and several other fragments may also be from such items. There is clear evidence that sections have been cut out of both pieces, with a possibility being that old items of horse tack were being used to repair leather shoes or boots. The cut-out shape of one of the pieces in Figure 54 is certainly the right size and shape to repair the toe of a leather soled boot or shoe.

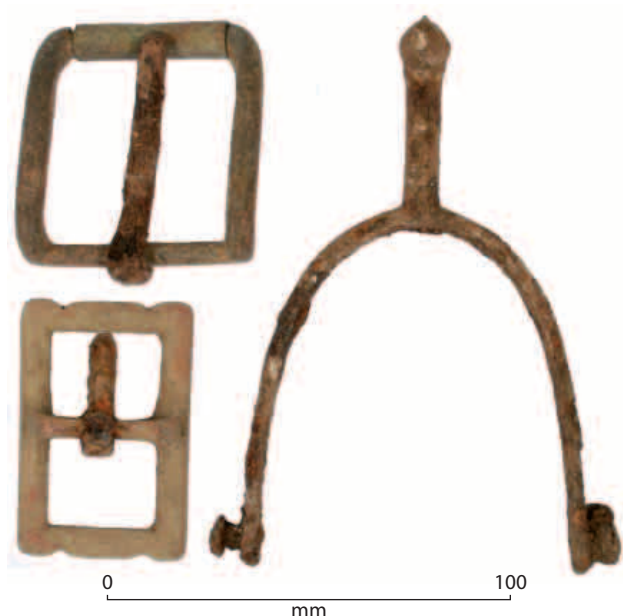
55 (bottom). Spur and buckles.
